TACTICAL BRIDGE ACCESS//GRESS PRELIMINARY
INVESTIGATIONS(U) ARMY ENGINEER WATERWAYS EXPERIMENT
STATION VICKSBURG MS GEOTECHNICAL LAB B A MATIS SEP 80

*Tactical Bridge Access/Egress
Preliminary Investigation*

Case, Gordon L.; Green, Hugh L.; Taylor, Hugh M. Sept. '80

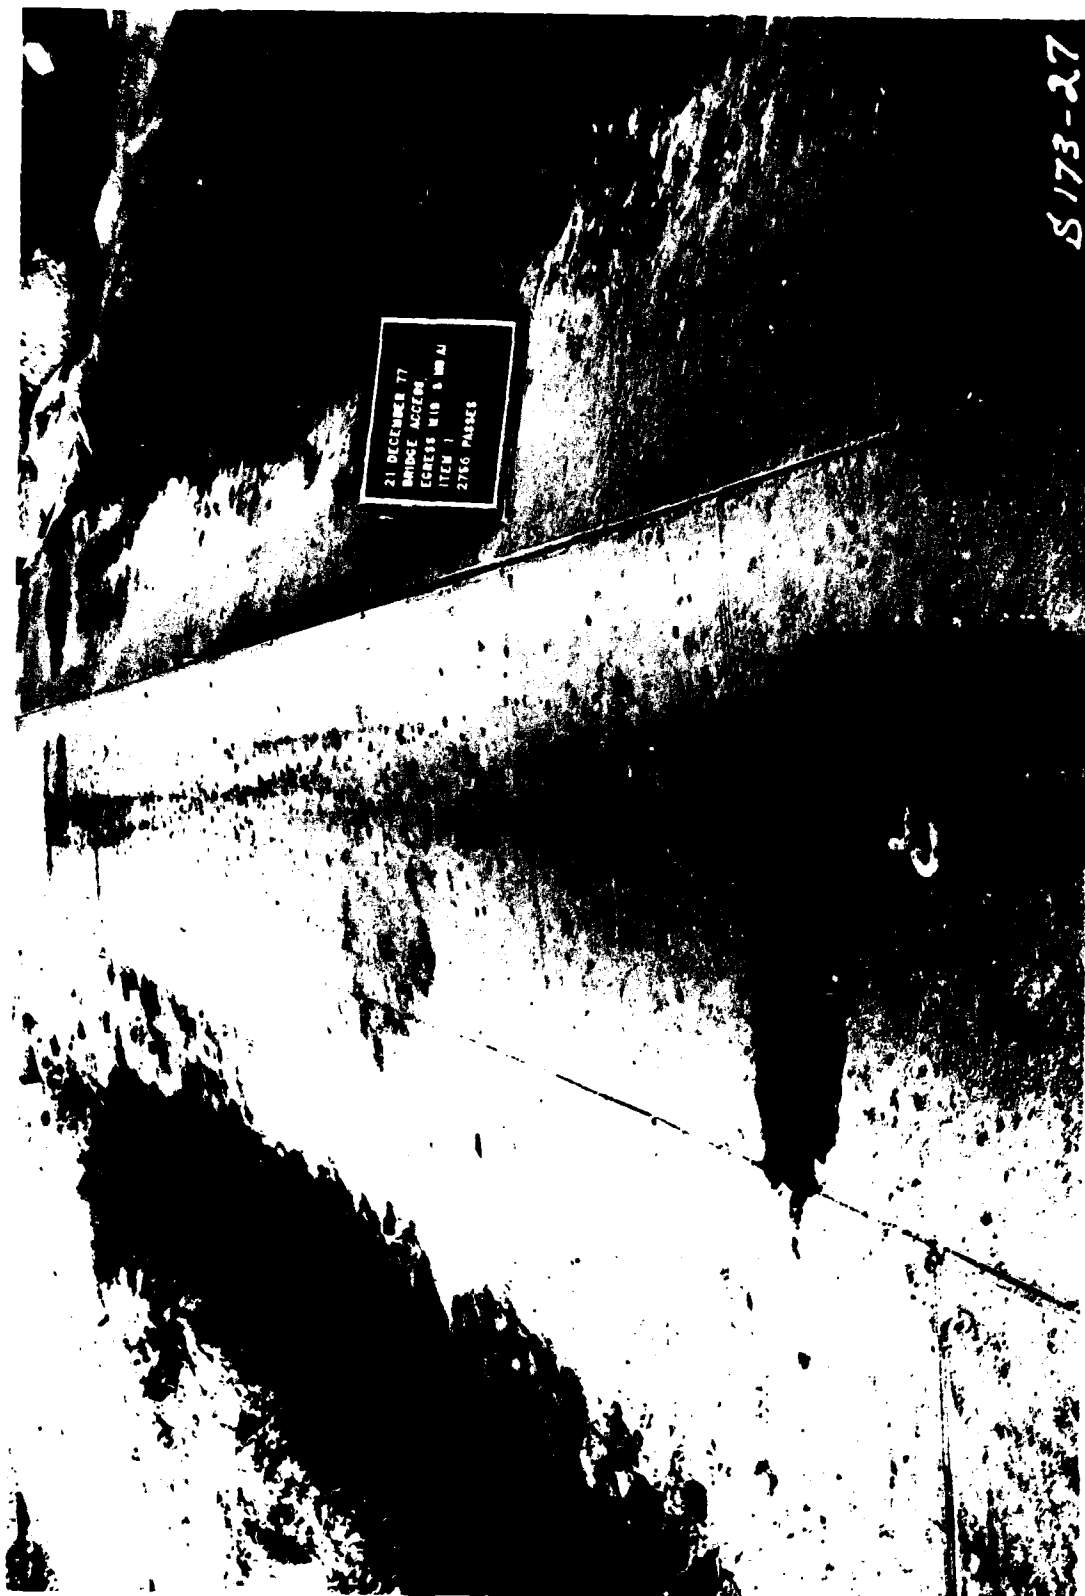
Item 1 after 56 passes of M48 tank and 2700 passes of M54 truck

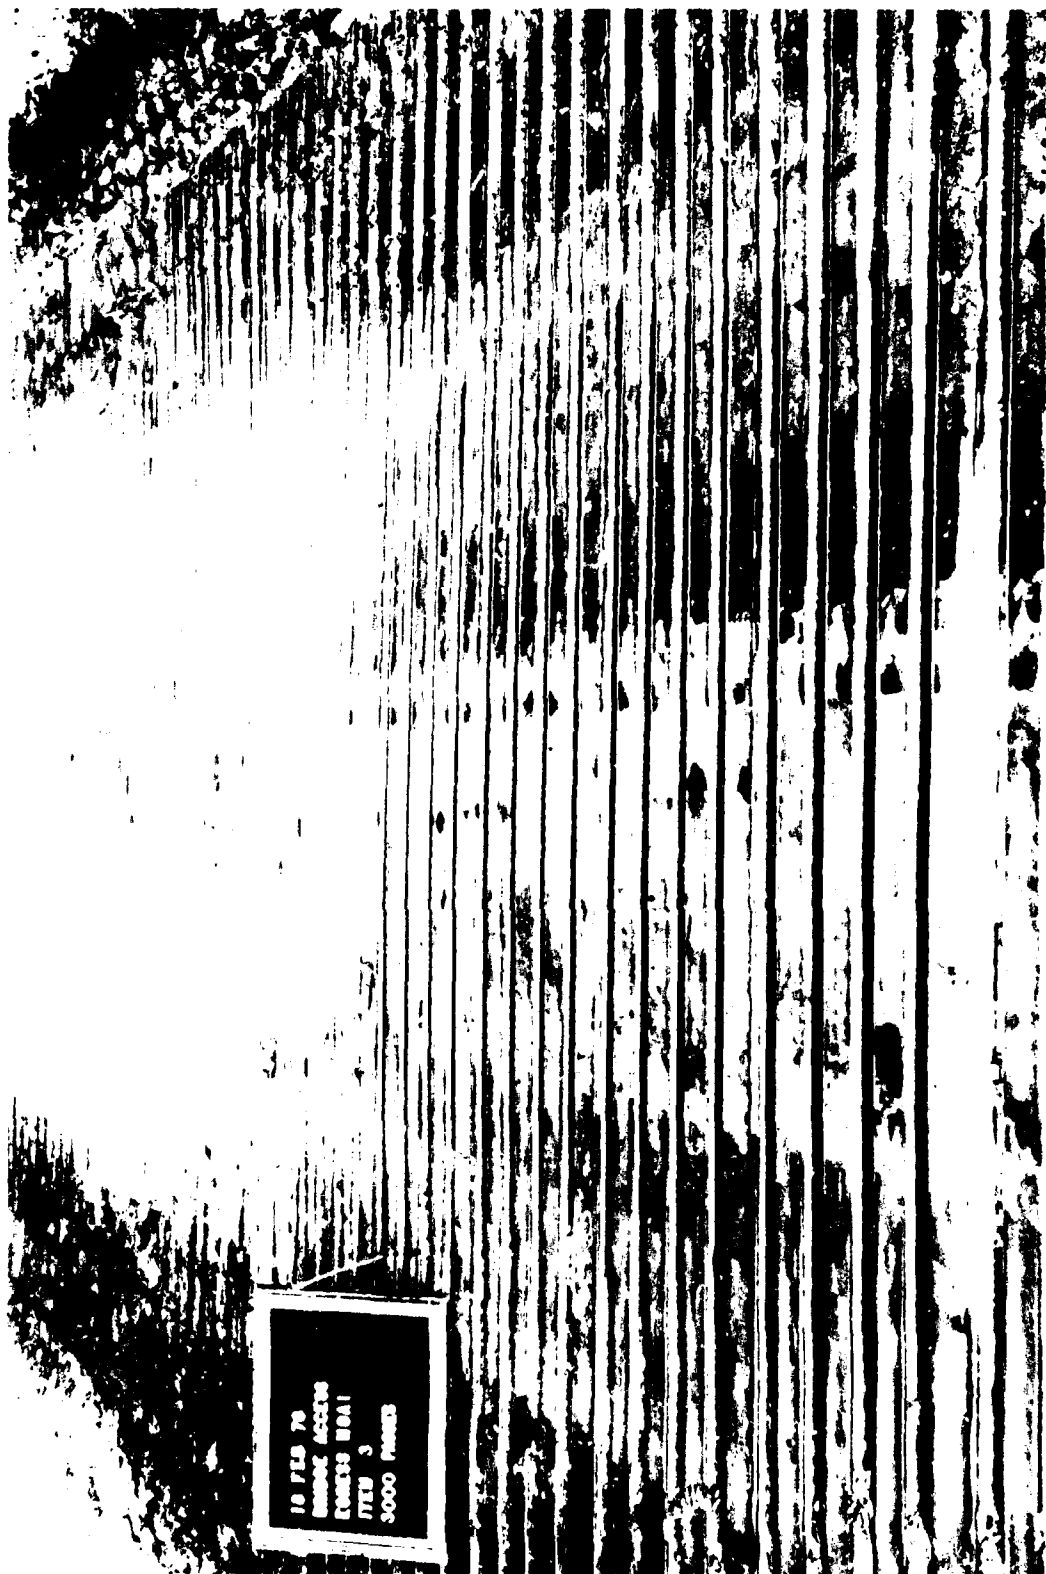
General view, Item 3, 3000 passes

7. After 3000 total passes, no damage had occurred to the mat. The outer edges of the mat were pushed down into the subgrade approximately 1-3/4 in. There was a minute change in the cross section and profile measurements from 2000 to 3000 total passes (Incl 14-20). A view of items 1, 2, and

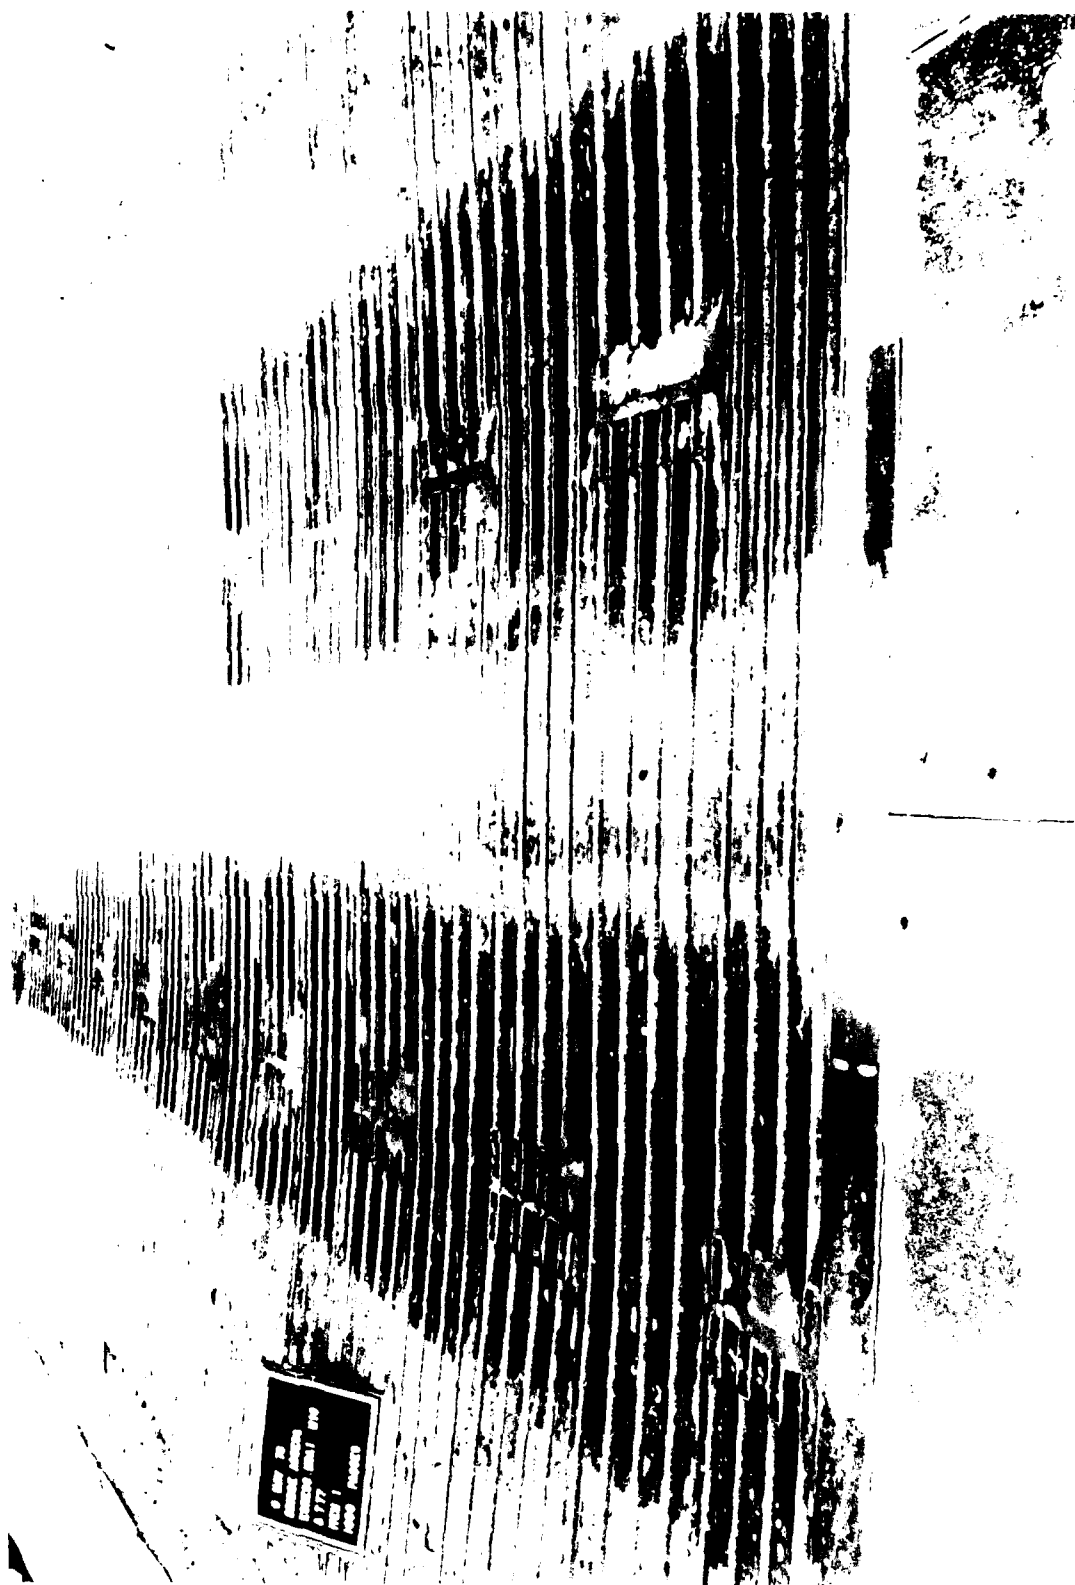
5. As traffic continued, the deformation along the truck wheel paths increased and subgrade material continued to be extruded up onto the mat surface; however, the mat remained in good condition and performed satisfactorily through 1800 truck passes (Incl 14). The maximum change in both cross-section (Incls 9 and 10) and profile (Incl 11) measurements from the beginning of traffic to 1800 passes of the M51 truck was 2.7 and 3.0 in. The permanent set measurements (Incl 12) indicated a maximum change of 5 in. in item 1 after 1800 passes. The east edge of the deformed mat was approximately 4-1/2 in. above the underlying subgrade.

Item 1 after 1800 truck passes

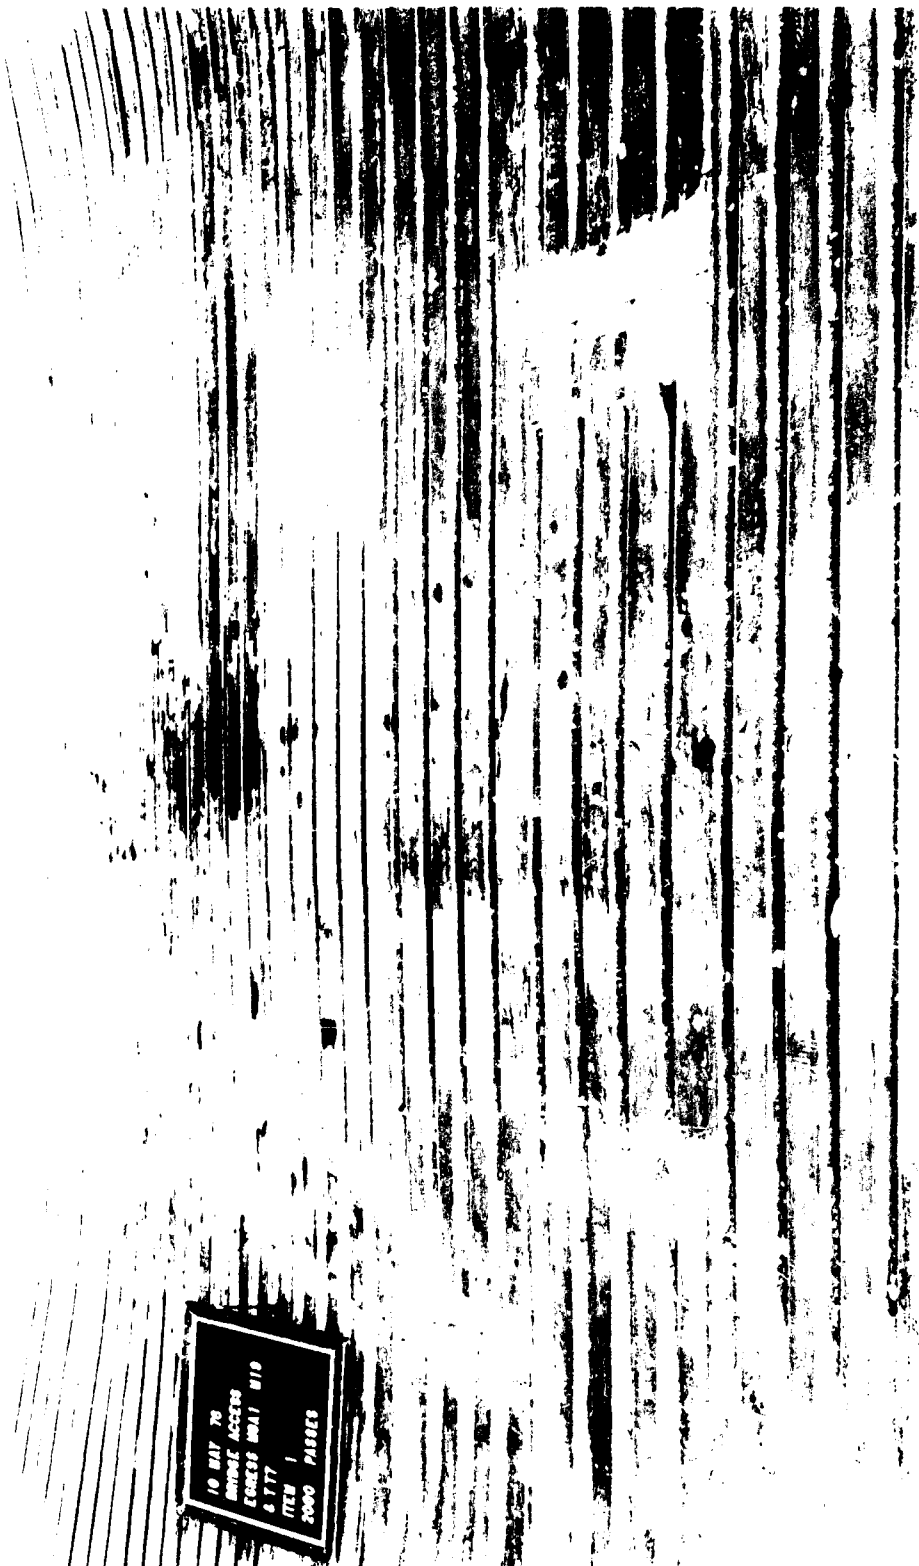
in the mat surface caused by 200 passes of the tank. The permanent set measurements (Incl 12) indicate an increase to 7 in. after 2000 total passes. After 3000 total passes, the mat was still in serviceable condition; however, several panels had breaks along the vehicle wheel paths. The maximum change in both cross-section (Incls 9 and 10) and profile (Incl 11) measurements from the beginning to 3000 total passes was 3.5 in. The item after 3000 total passes is shown on Incl 17.

View of item 1 at the conclusion of traffic

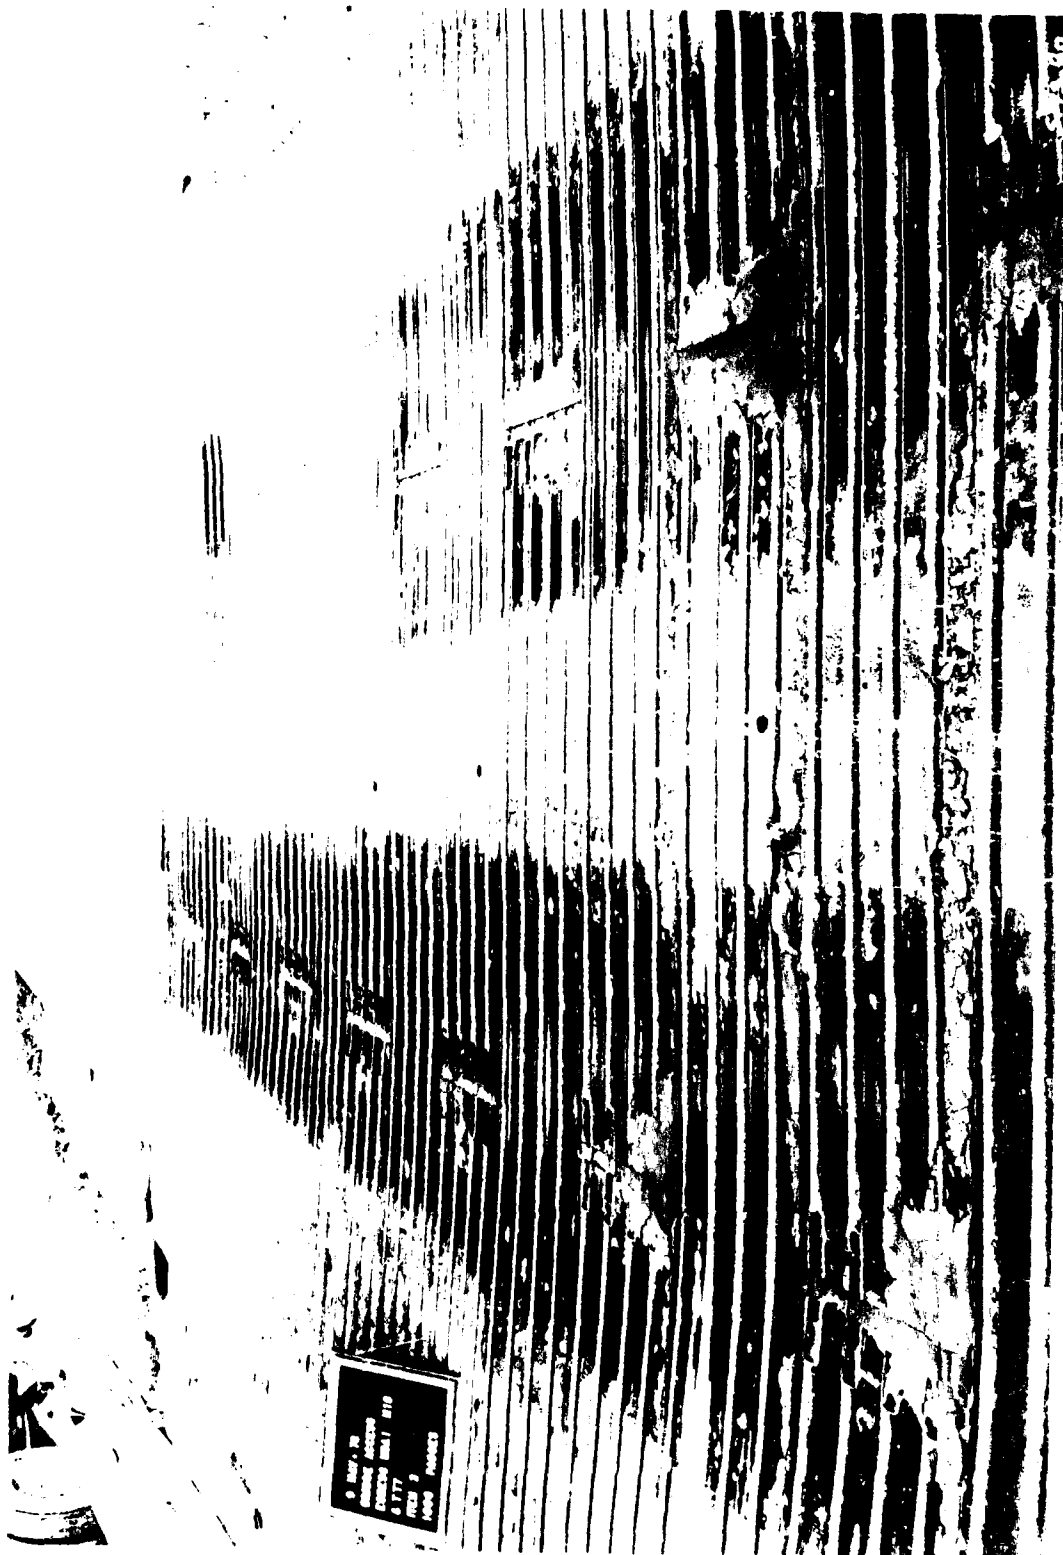
Item 2 after 1800 truck passenger

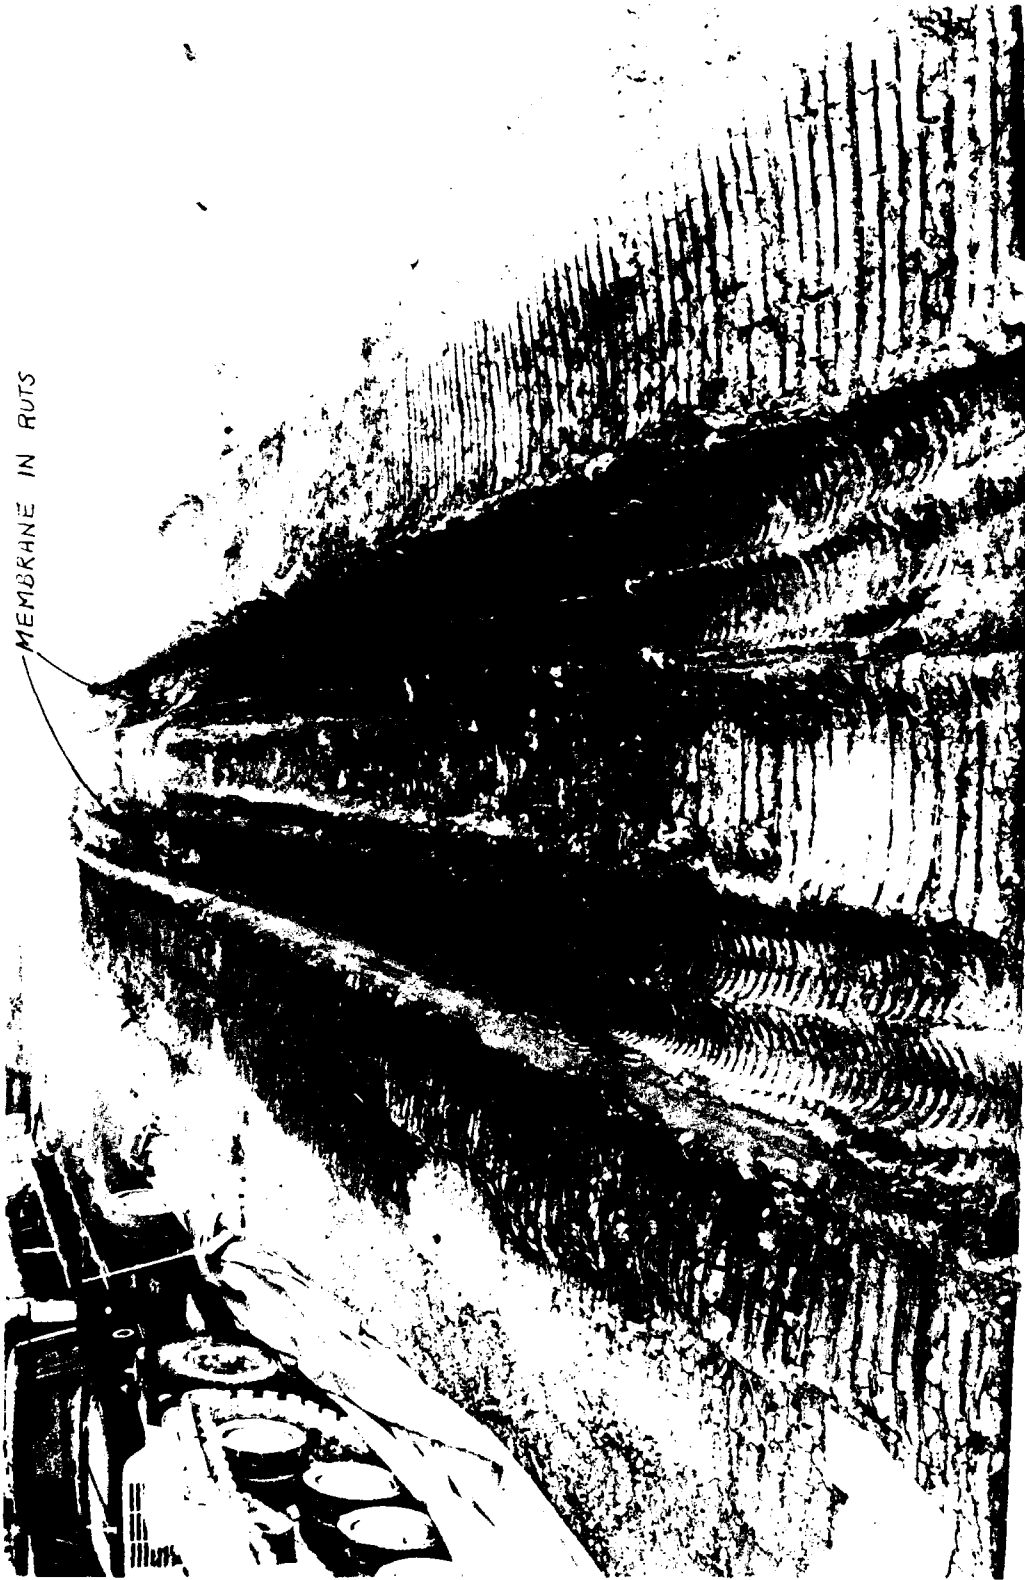
Overall view of the roof section after 10 years.
Note: Membrane in rutting zone.

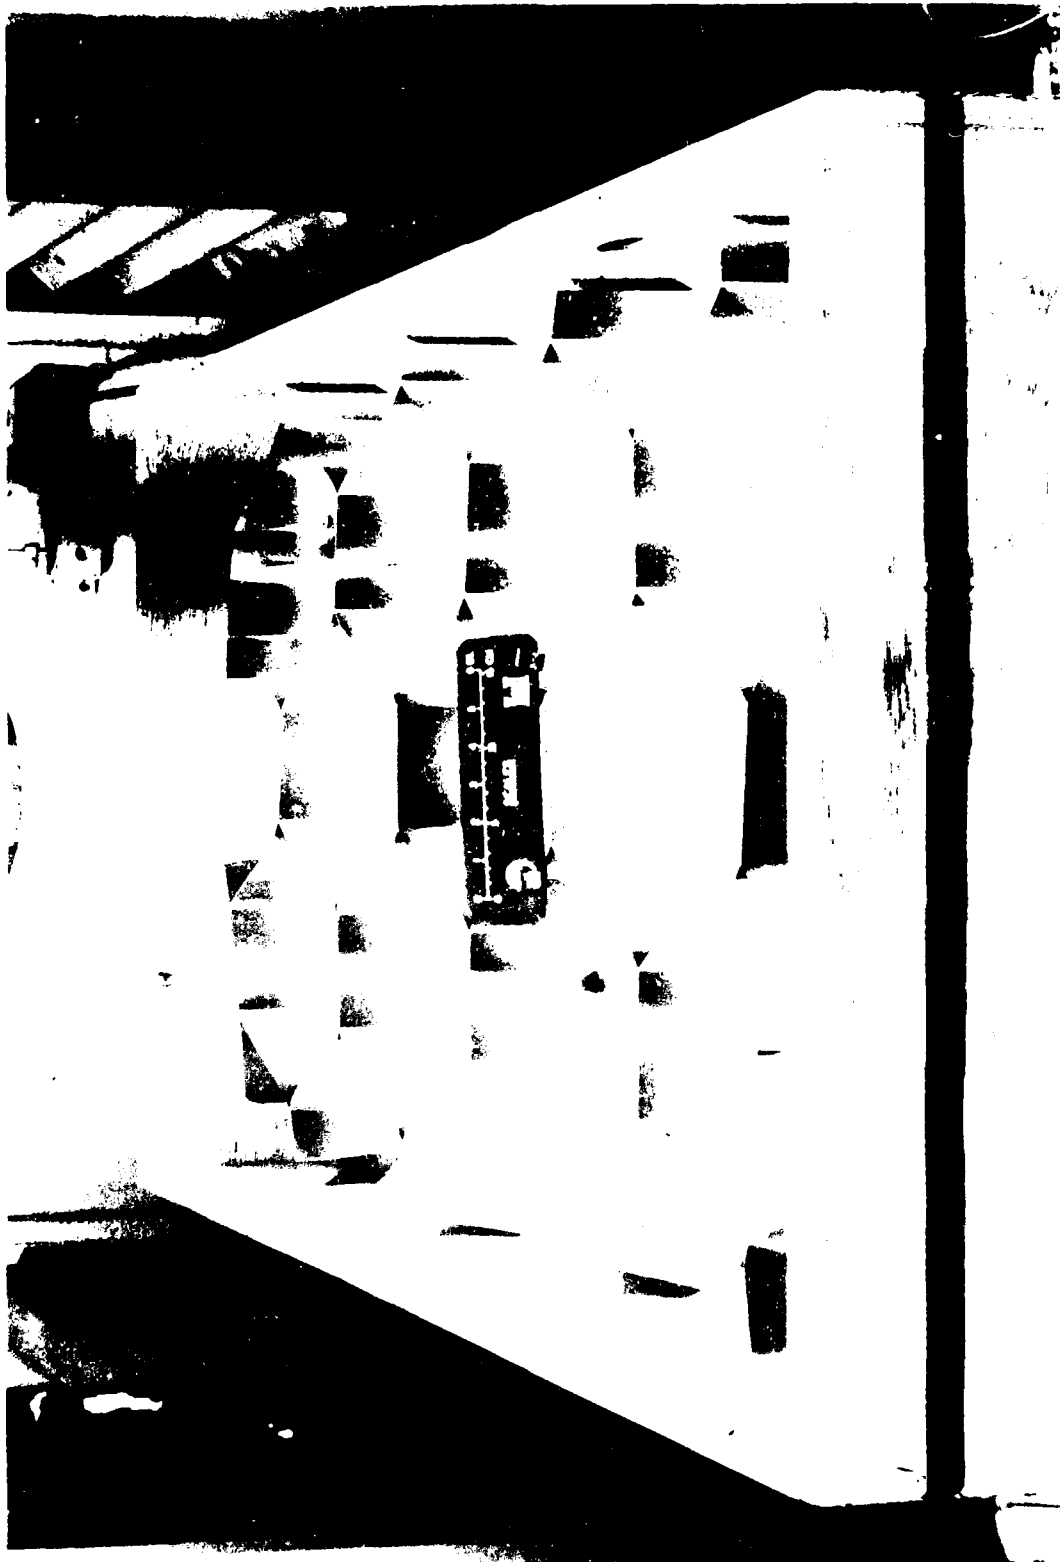
6 inch aluminum cell grid, 6 inches deep prior to filling with sand for laboratory tests

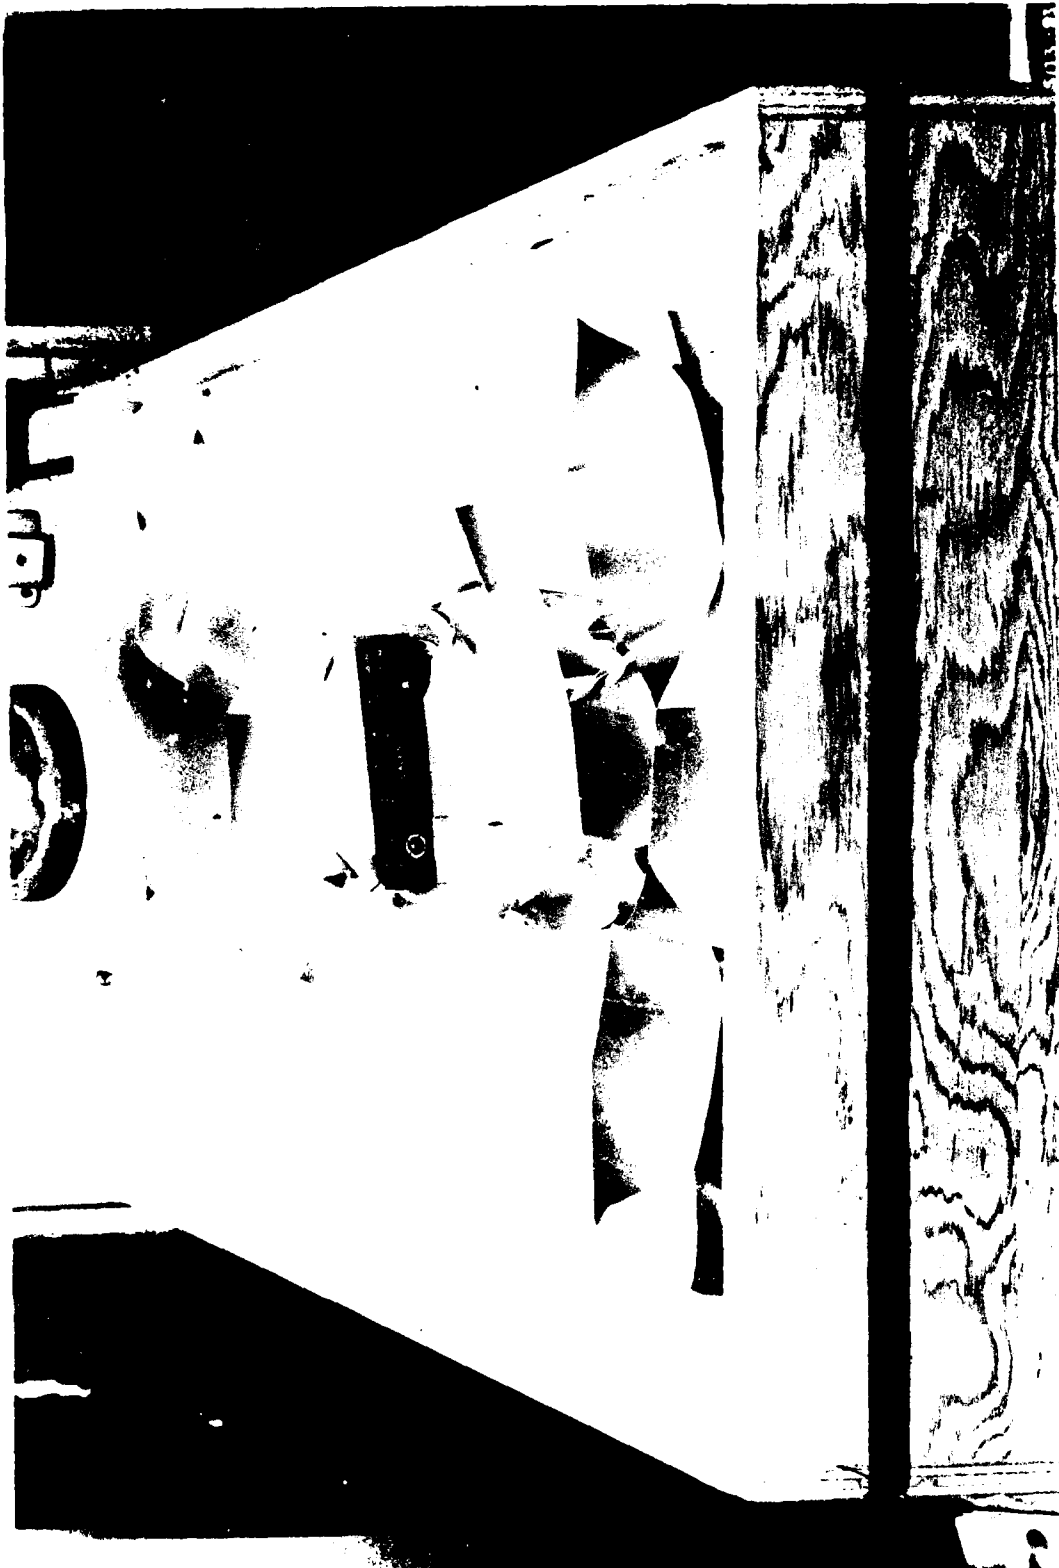
Aluminum grid after laboratory tests

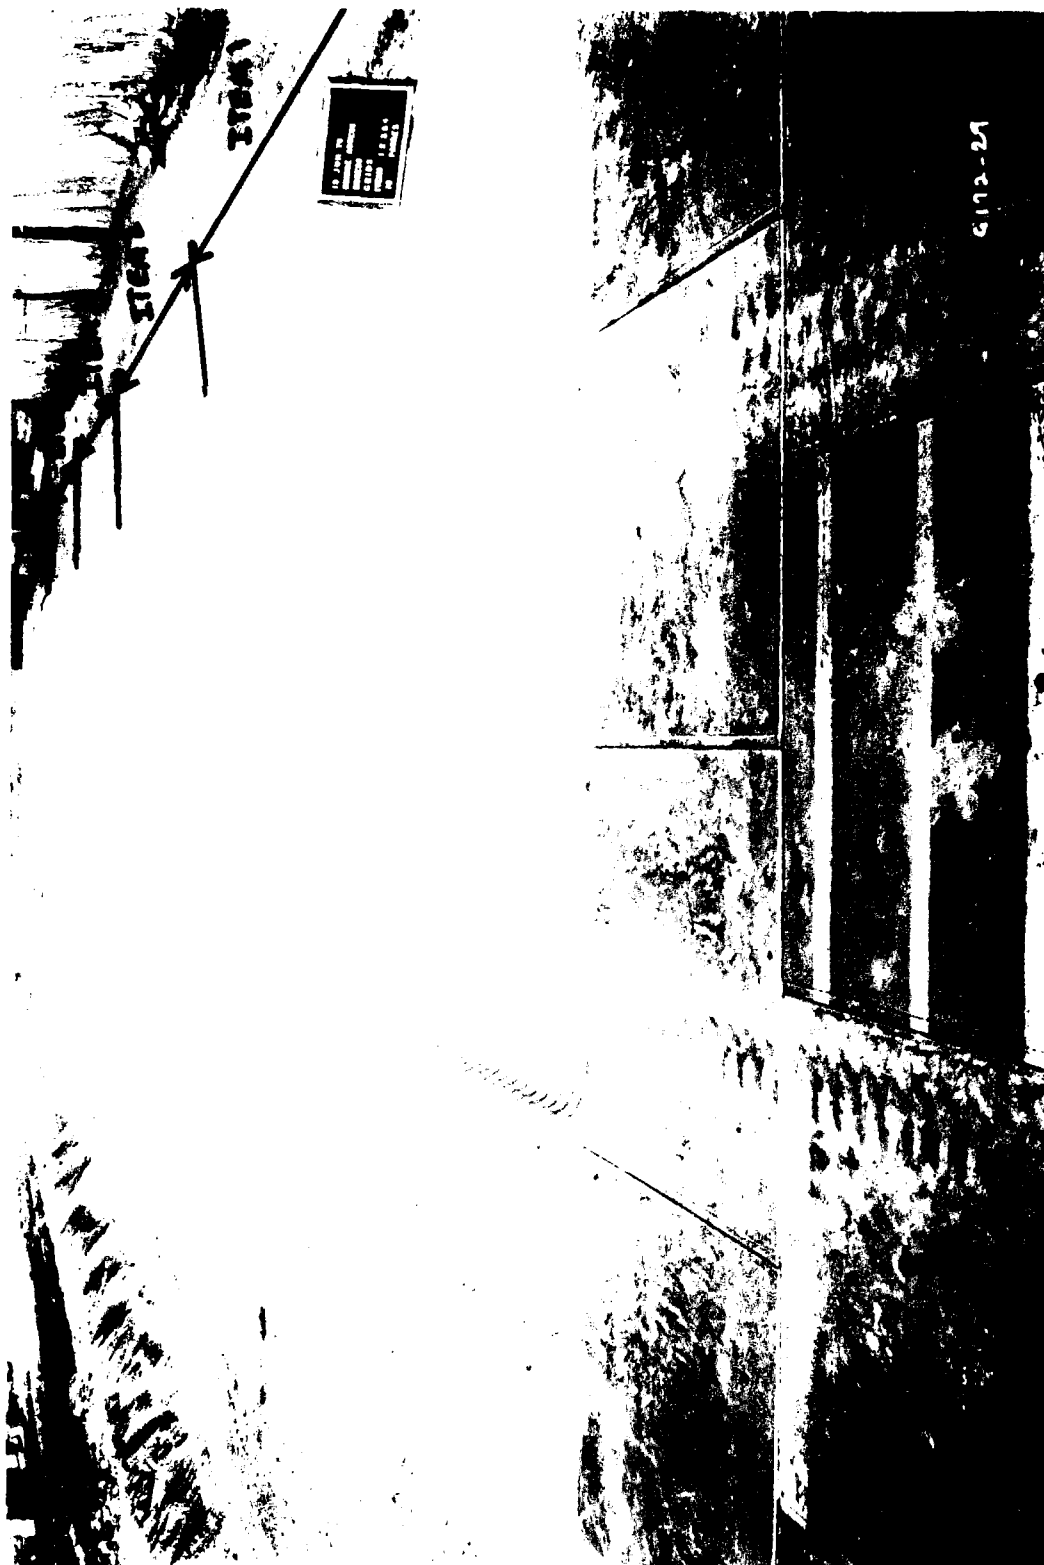
Incl 23

12. A view of the test section after 10 passes of the M54 truck is shown on Incl 23. Some rutting and compaction of the sand and grids had occurred. No visible evidence of deformation of the grids was observed. However, when the sand was removed from the top of some of the grids in one wheel path, some deformation and tears were observed. Details of the individual items are given in the following paragraphs.

Test section after 10 passes of traffic

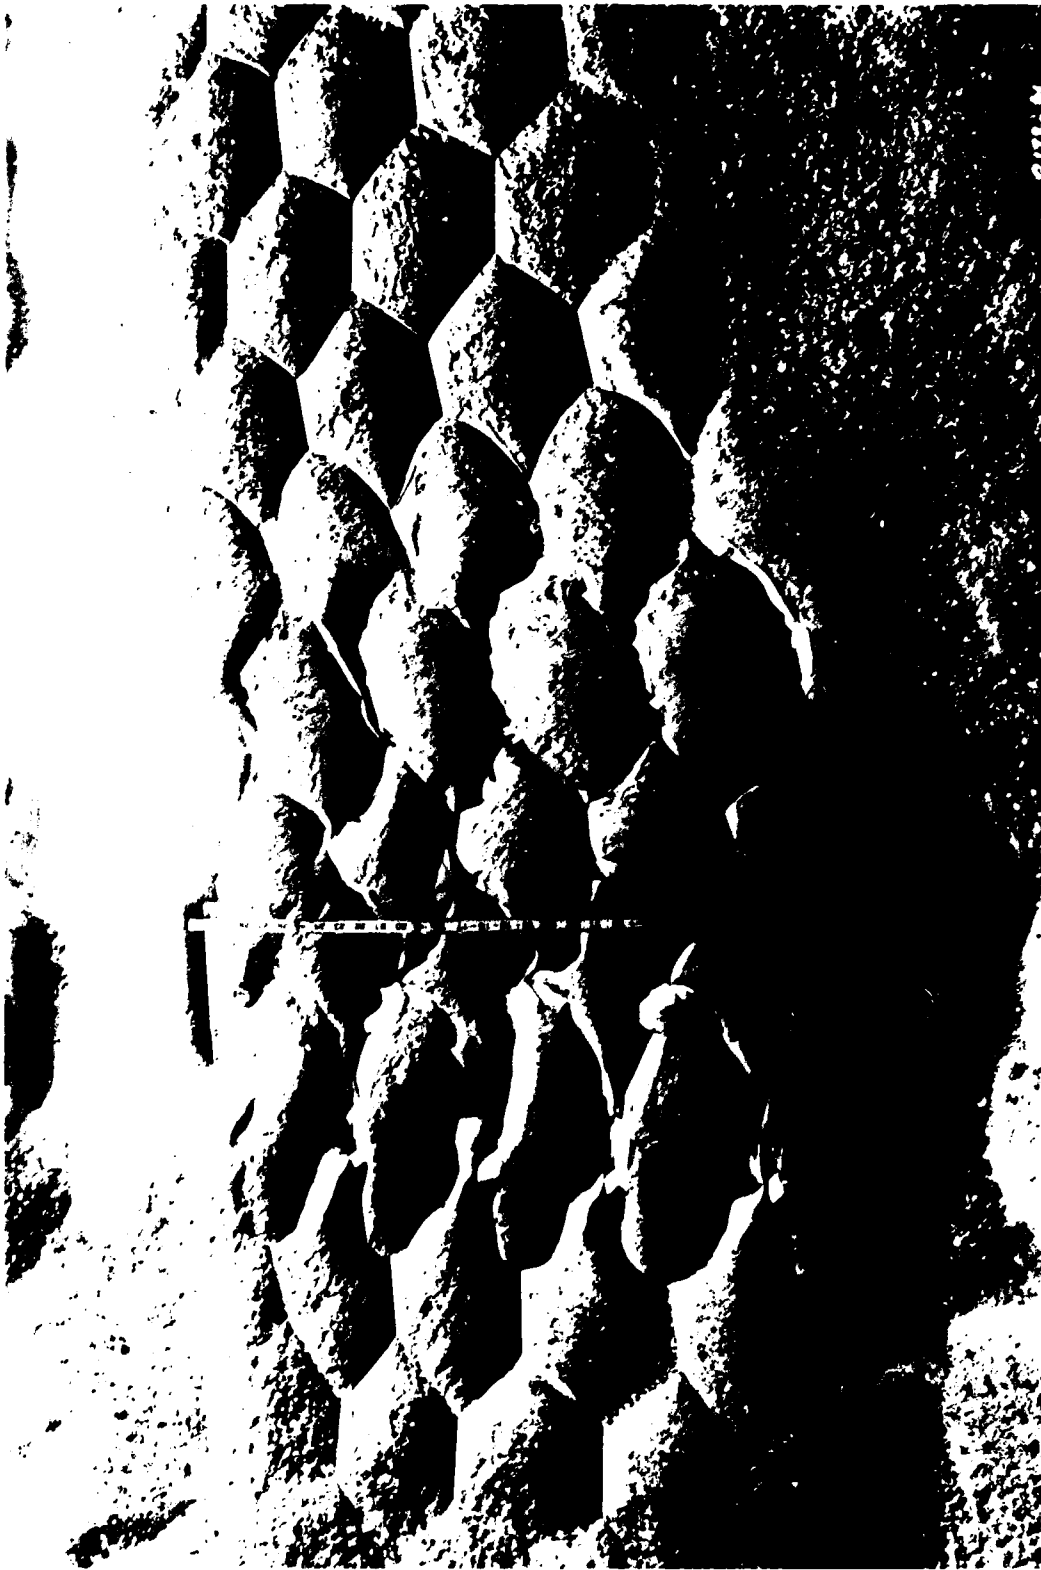
Grid in item 1 after 1000 passes

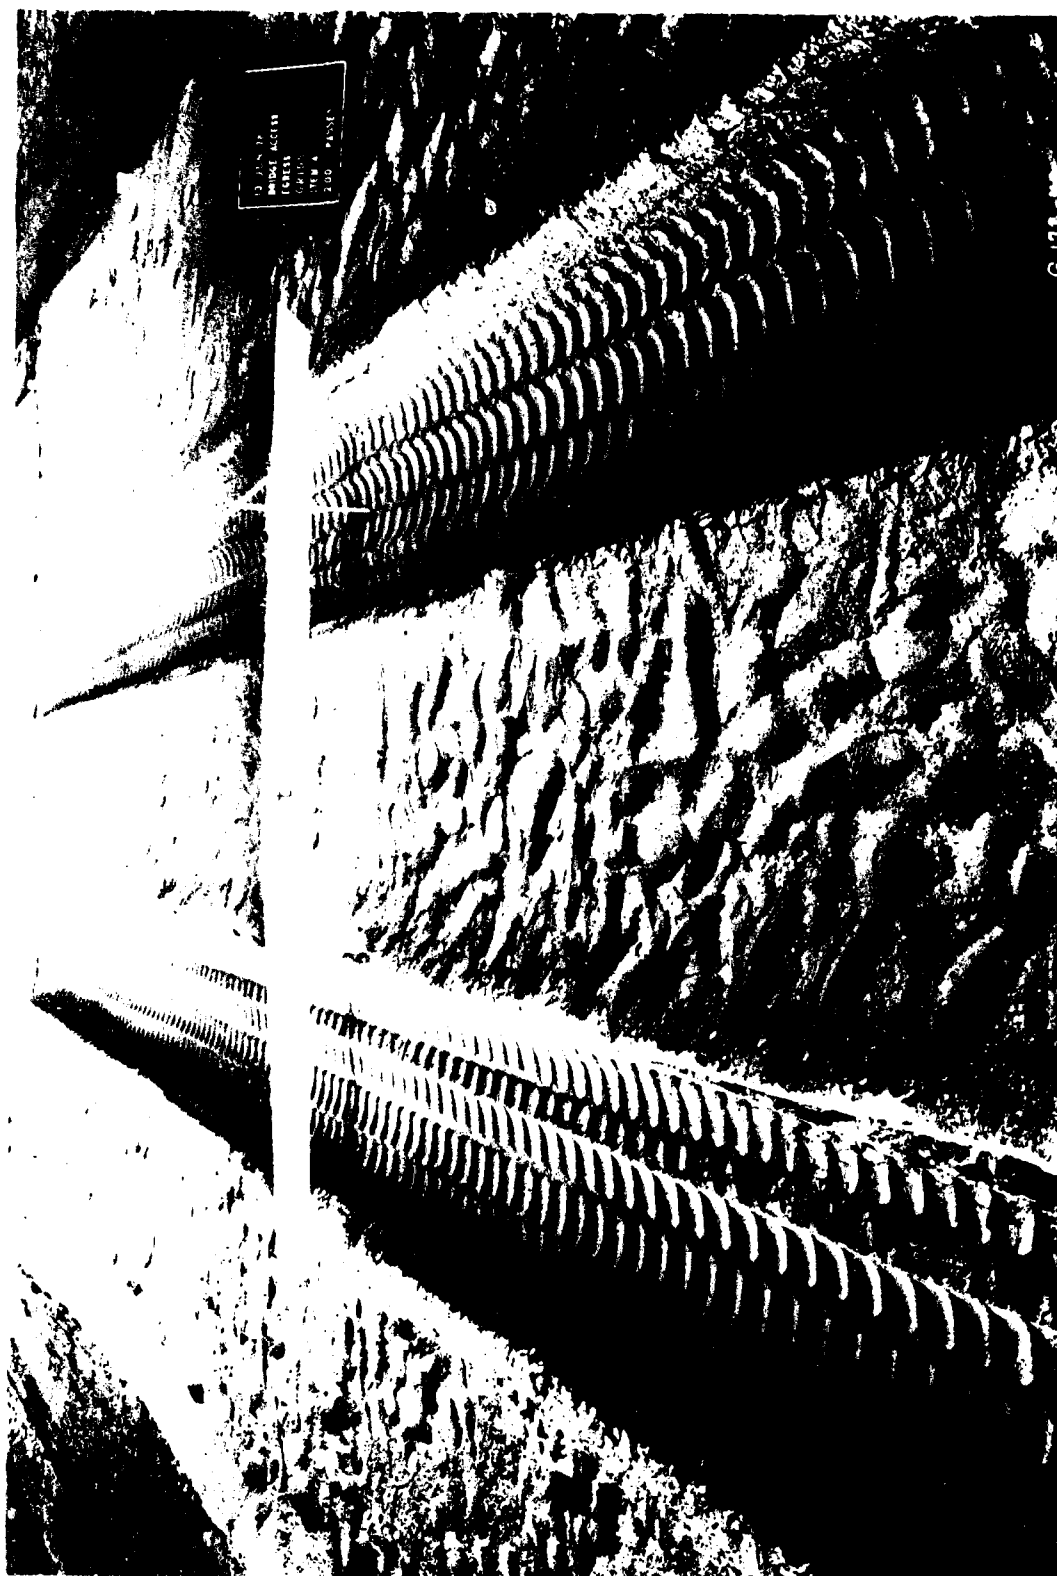
Incl 42

Item 4 after 200 passes

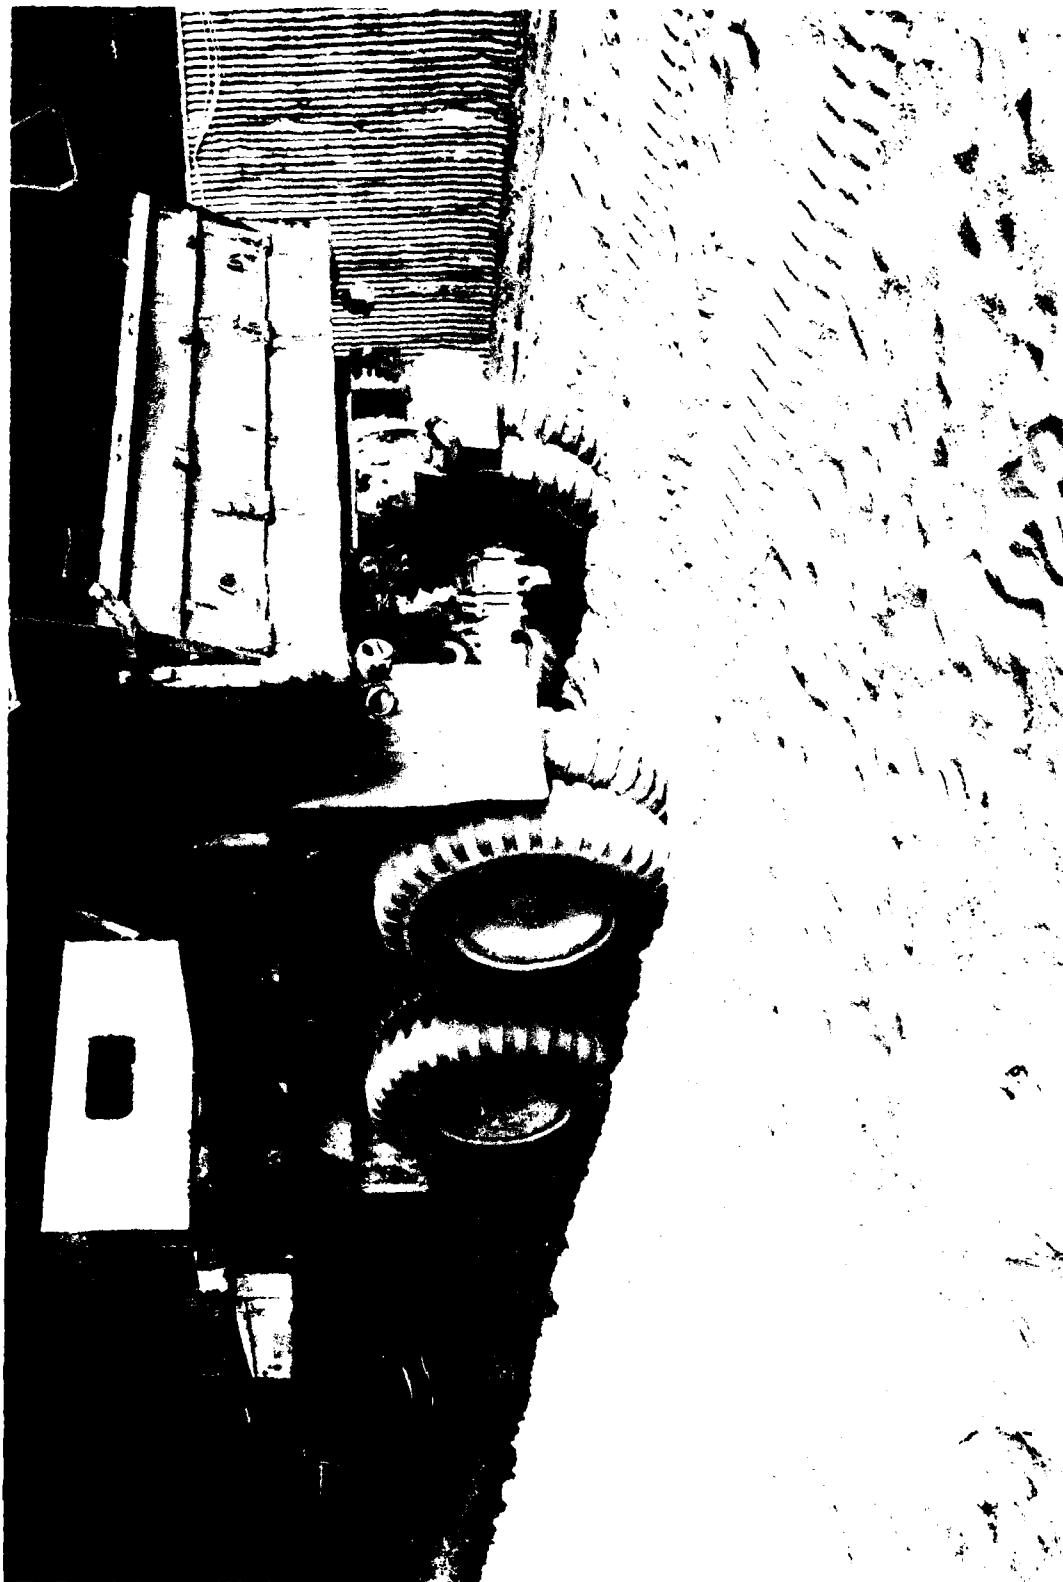
Incl 46

M54 cargo truck on items 1 and 2 after 1000 passes of traffic

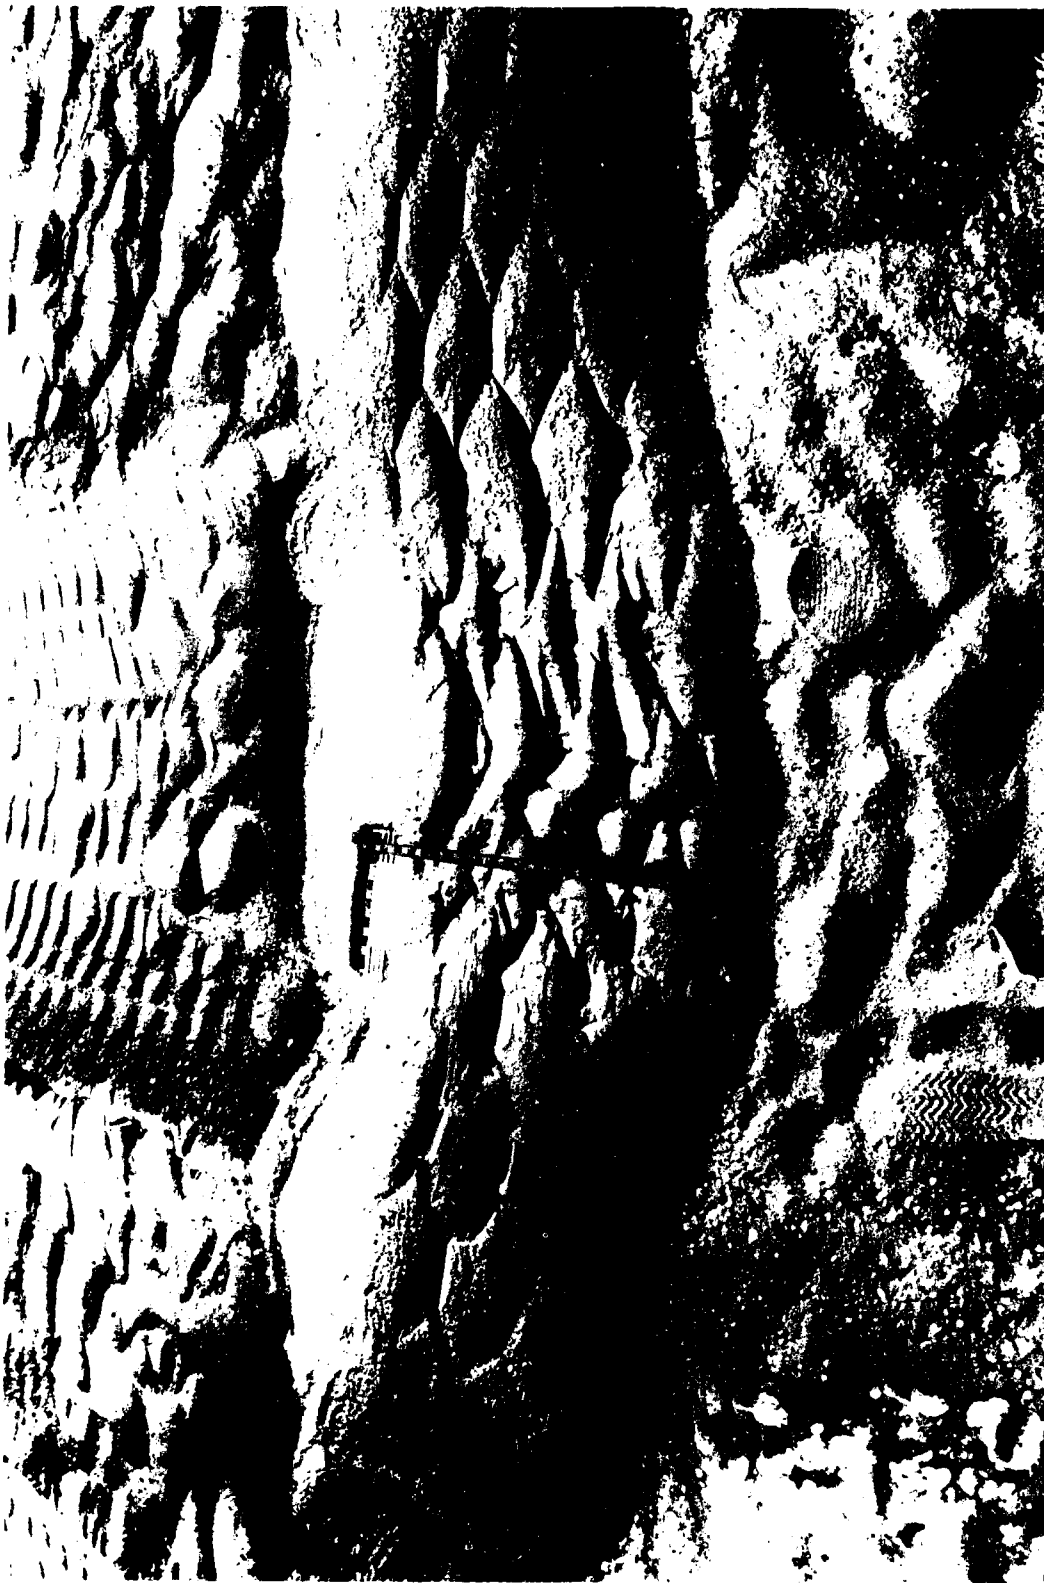
Grid in item 7 after 1000 passes
